waters edge
AQUATIC DESIGN

Existing Conditions - Super Splash USA

December 14, 2015

Super Splash

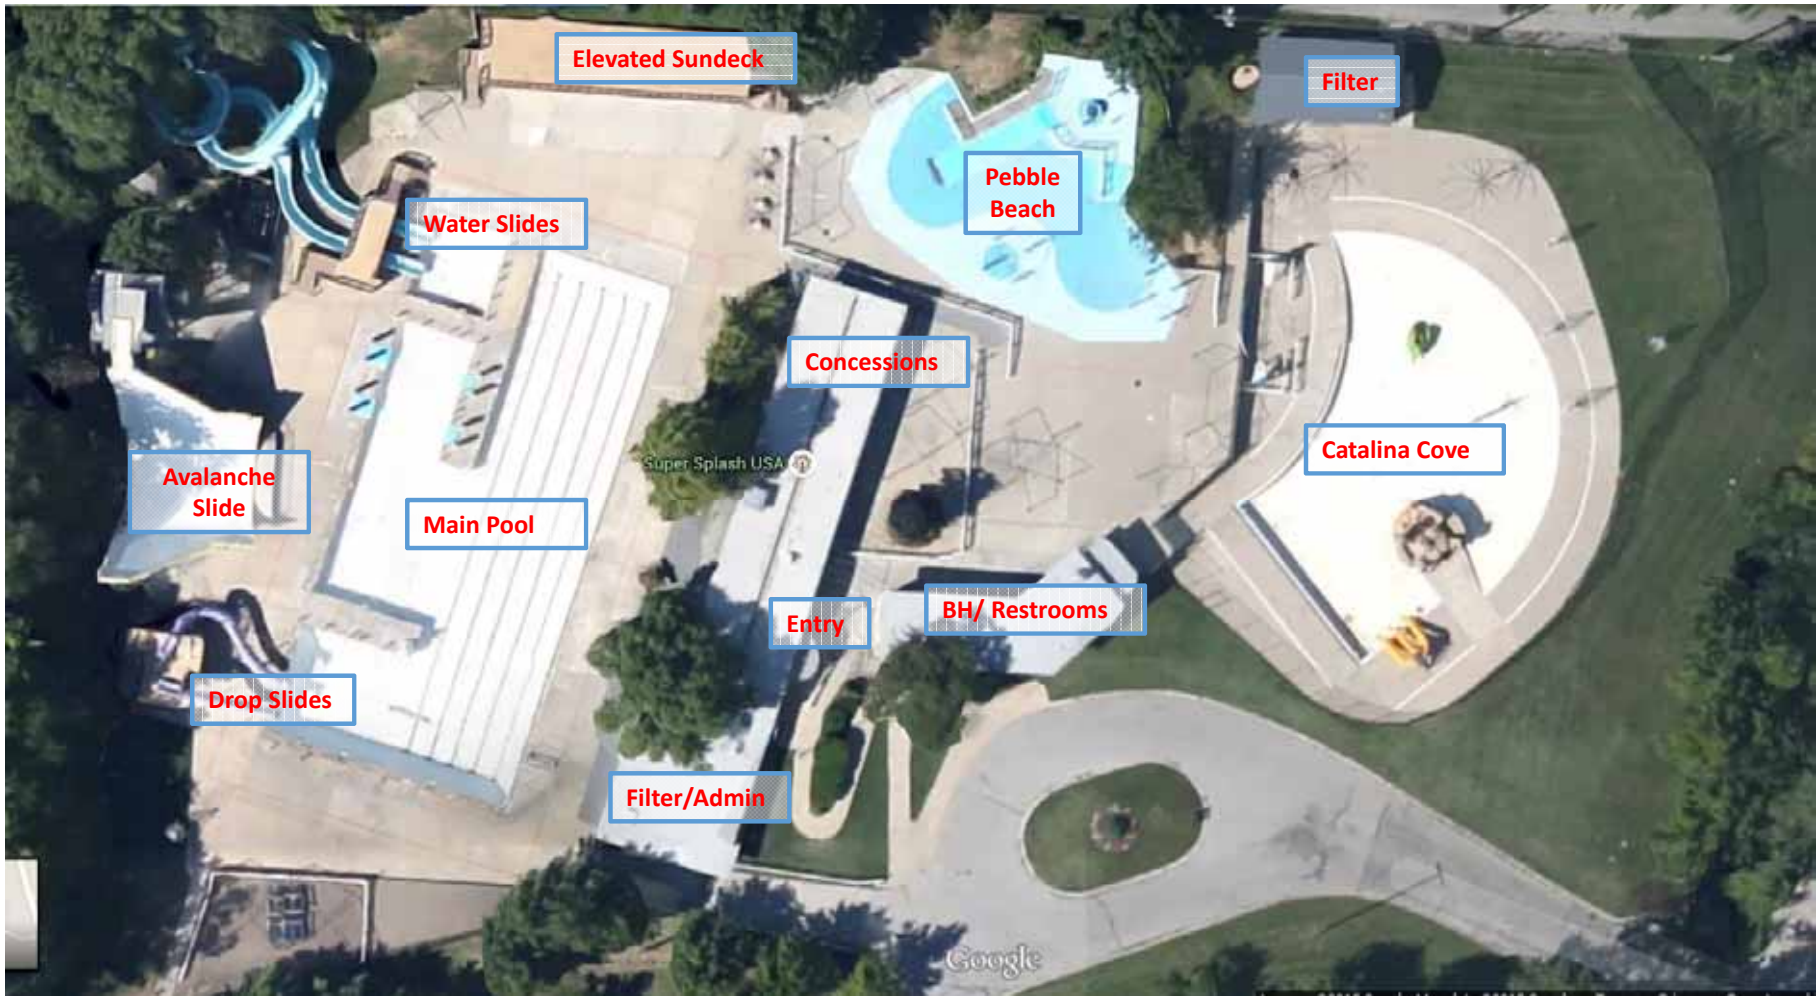
Flume Slides

- Pump is aging- could fail in-season?

Main Pool & Plunge-

- Coating is failing
- Misc. Concrete Repair
- Substantial Water Loss (piping failing)

Avalanche & Drop Slides

- Structures rusting
- Operate as-is, until close?

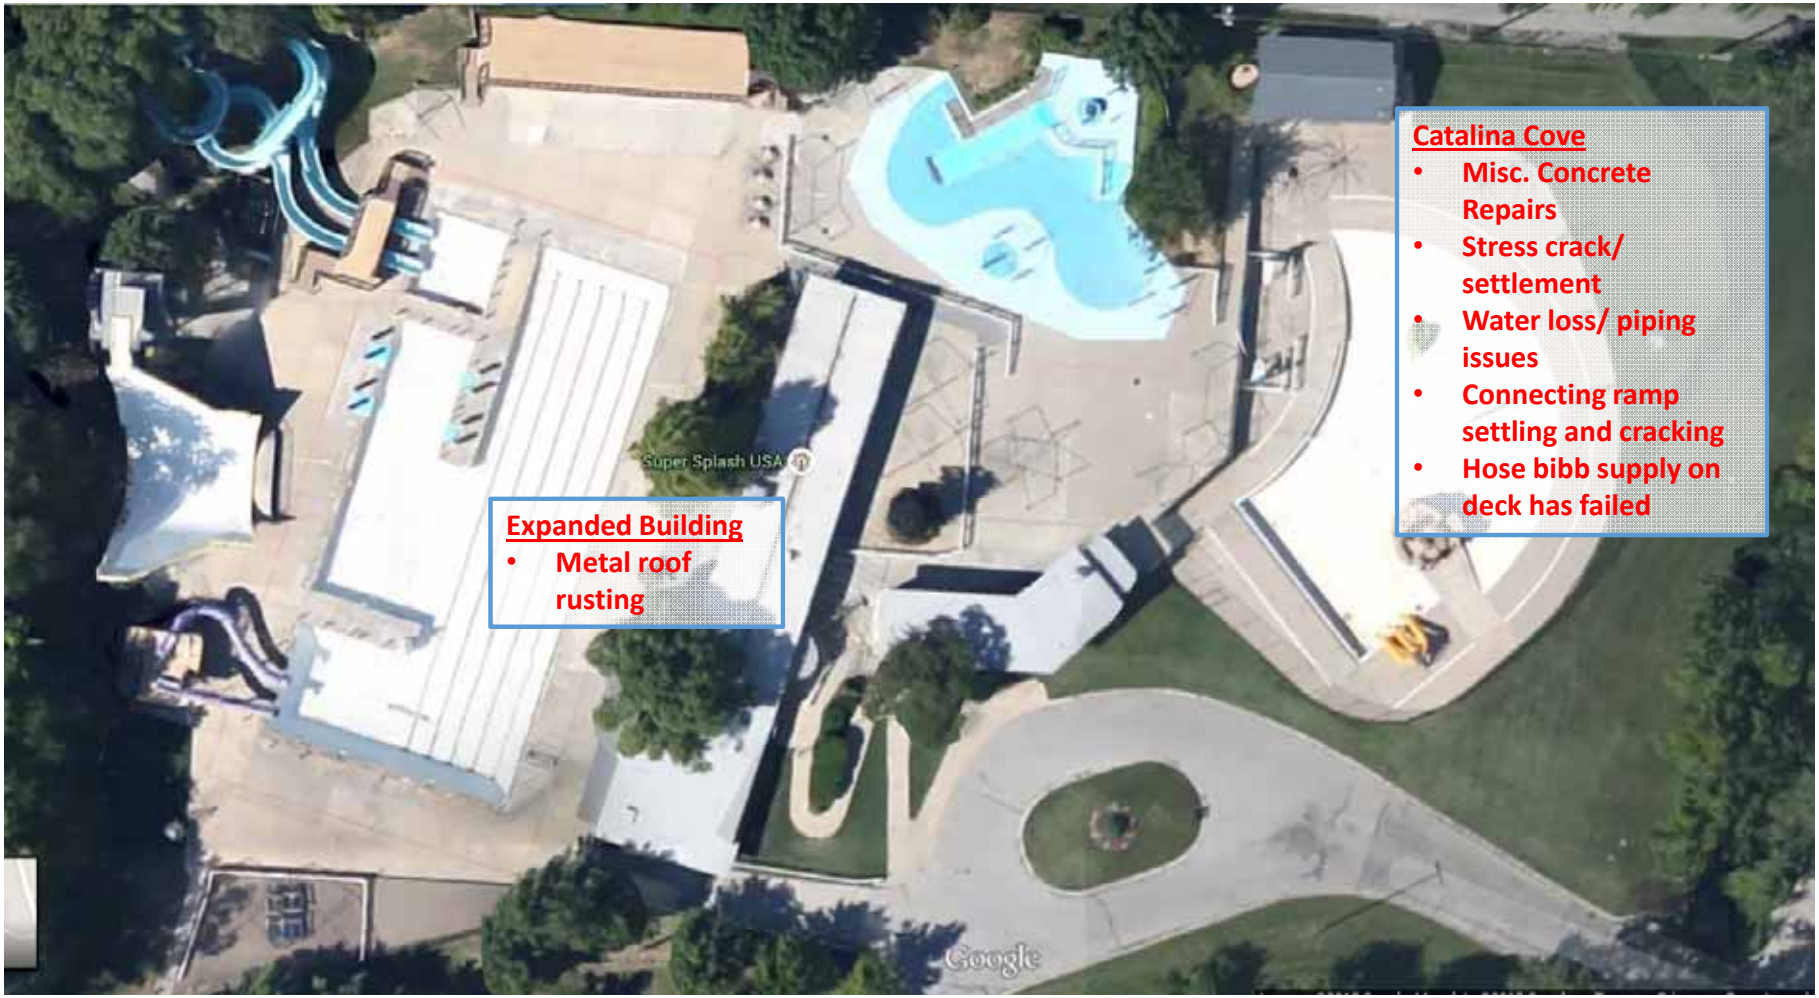
Expanded Building

- Metal roof rusting

Catalina Cove

- Misc. Concrete Repairs
- Stress crack/ settlement
- Water loss/ piping issues
- Connecting ramp settling and cracking
- Hose bibb supply on deck has failed
